Lecture in Department of Civil & Architecture School of UPT

**LESSONS LEARNED FROM RECENT EARTHQUAKES:
OBSERVED DAMAGE AND NEW TYPES OF STEEL
CONNECTIONS**

ANASTASIADIS ANTHIMOS

1st Part – OBSERVED DAMAGE FROM EARTHQUAKES

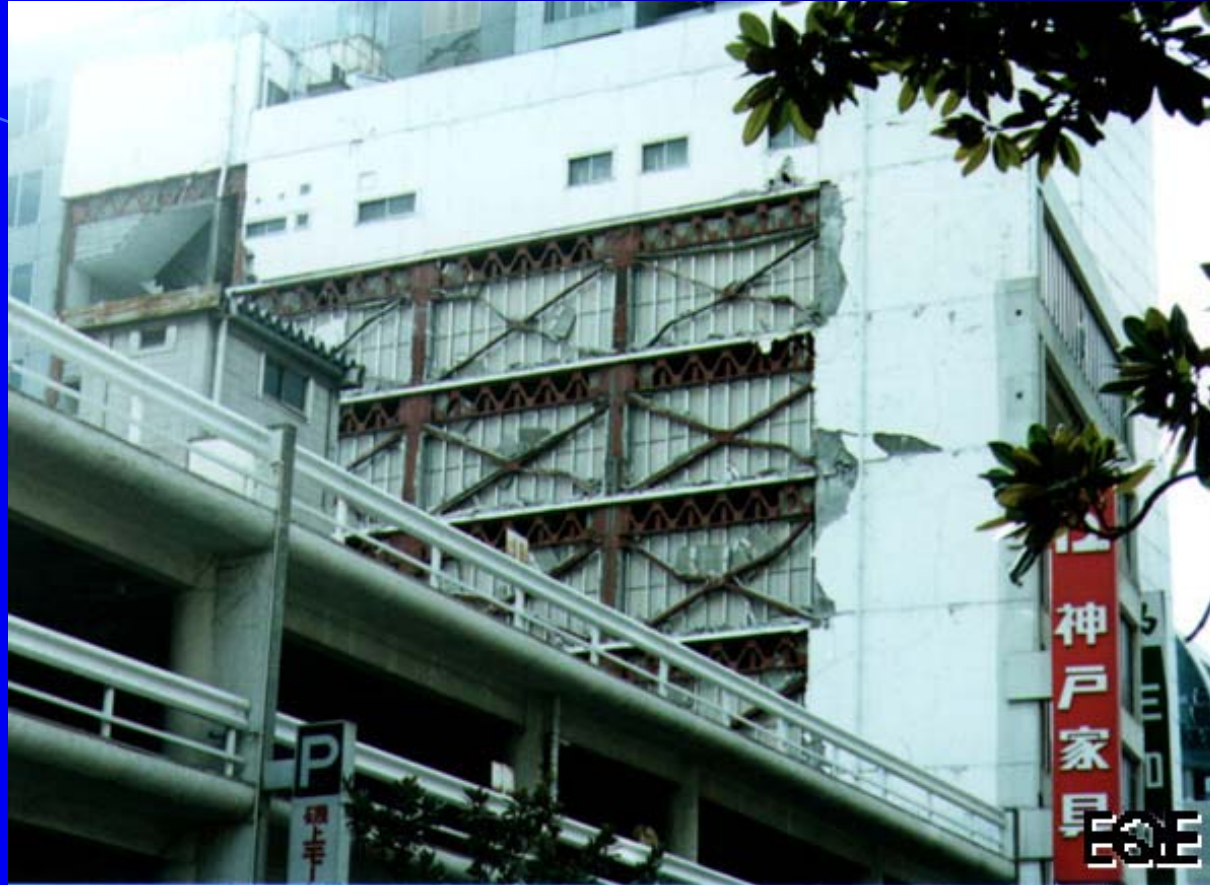
Buckling of Bracings, (Kobe Earthquake 1995)

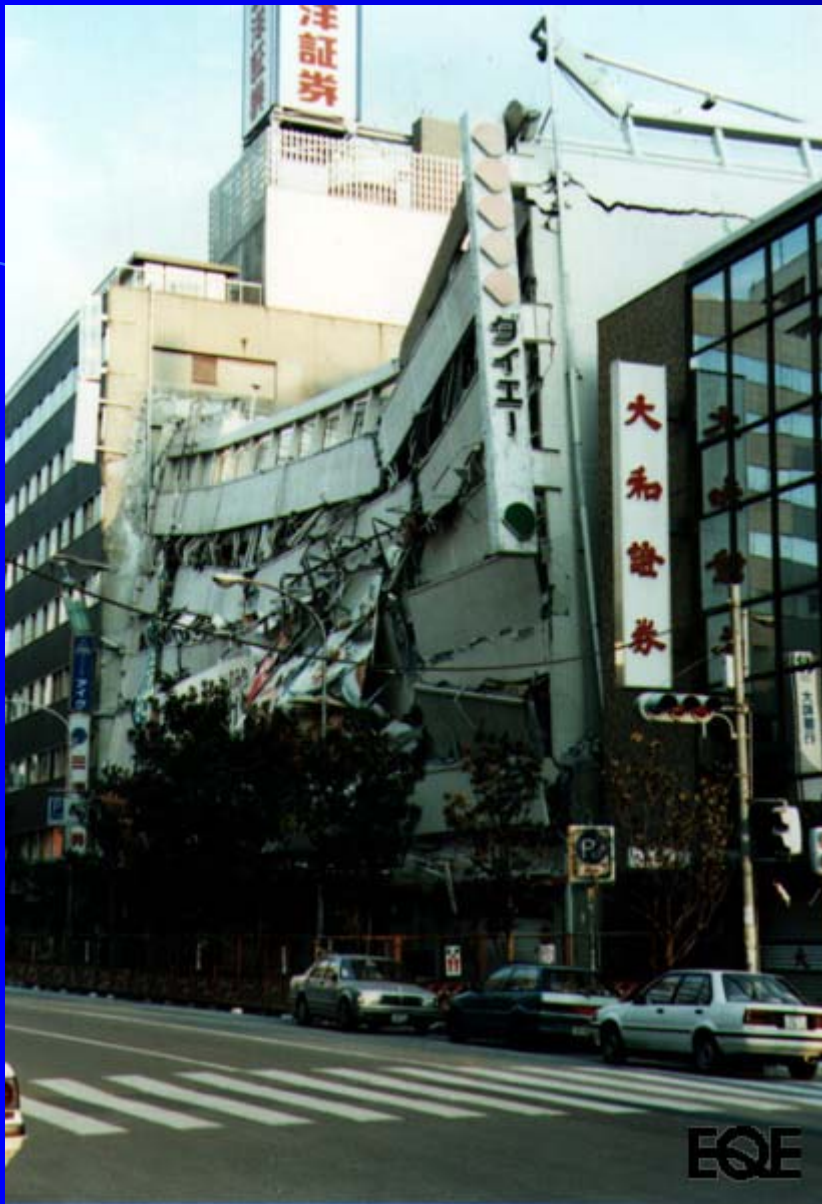
Soft storey
mechanism of
intermediate story
due to higher modes
of vibration

Kobe Earthquake,
1995)

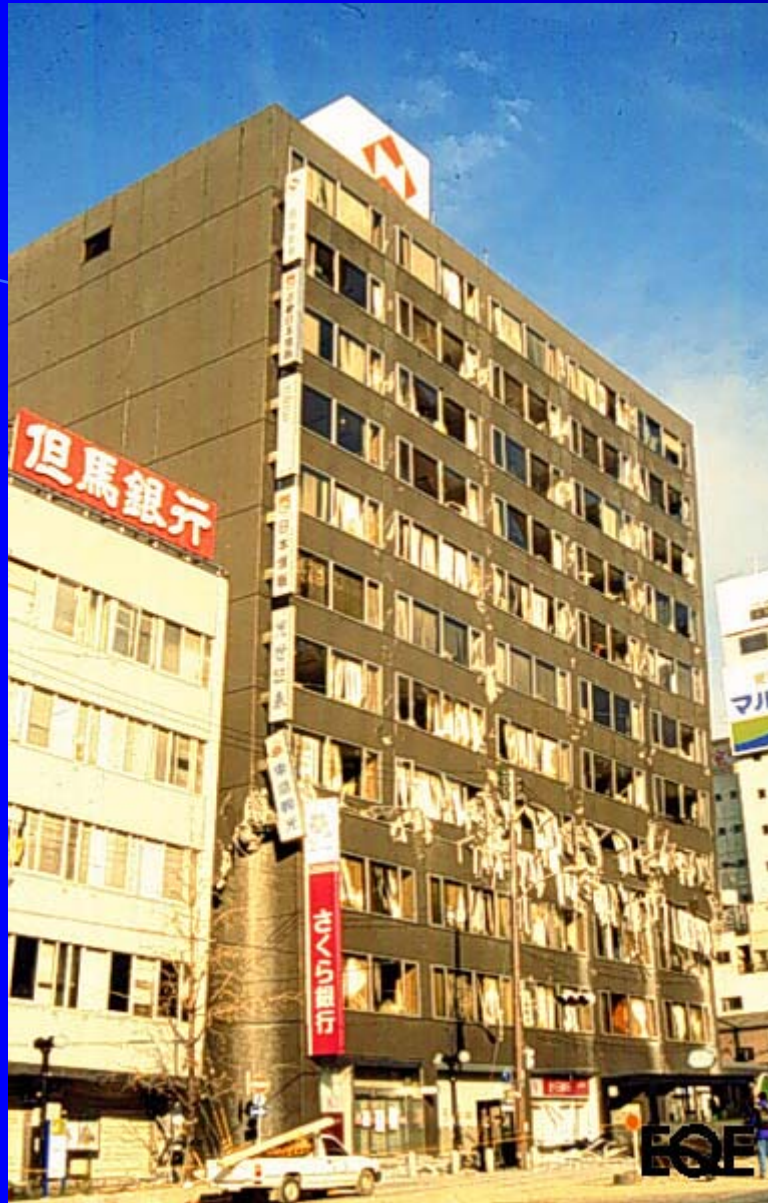
Soft storey
mechanism of
intermediate story
due to higher modes
of vibration

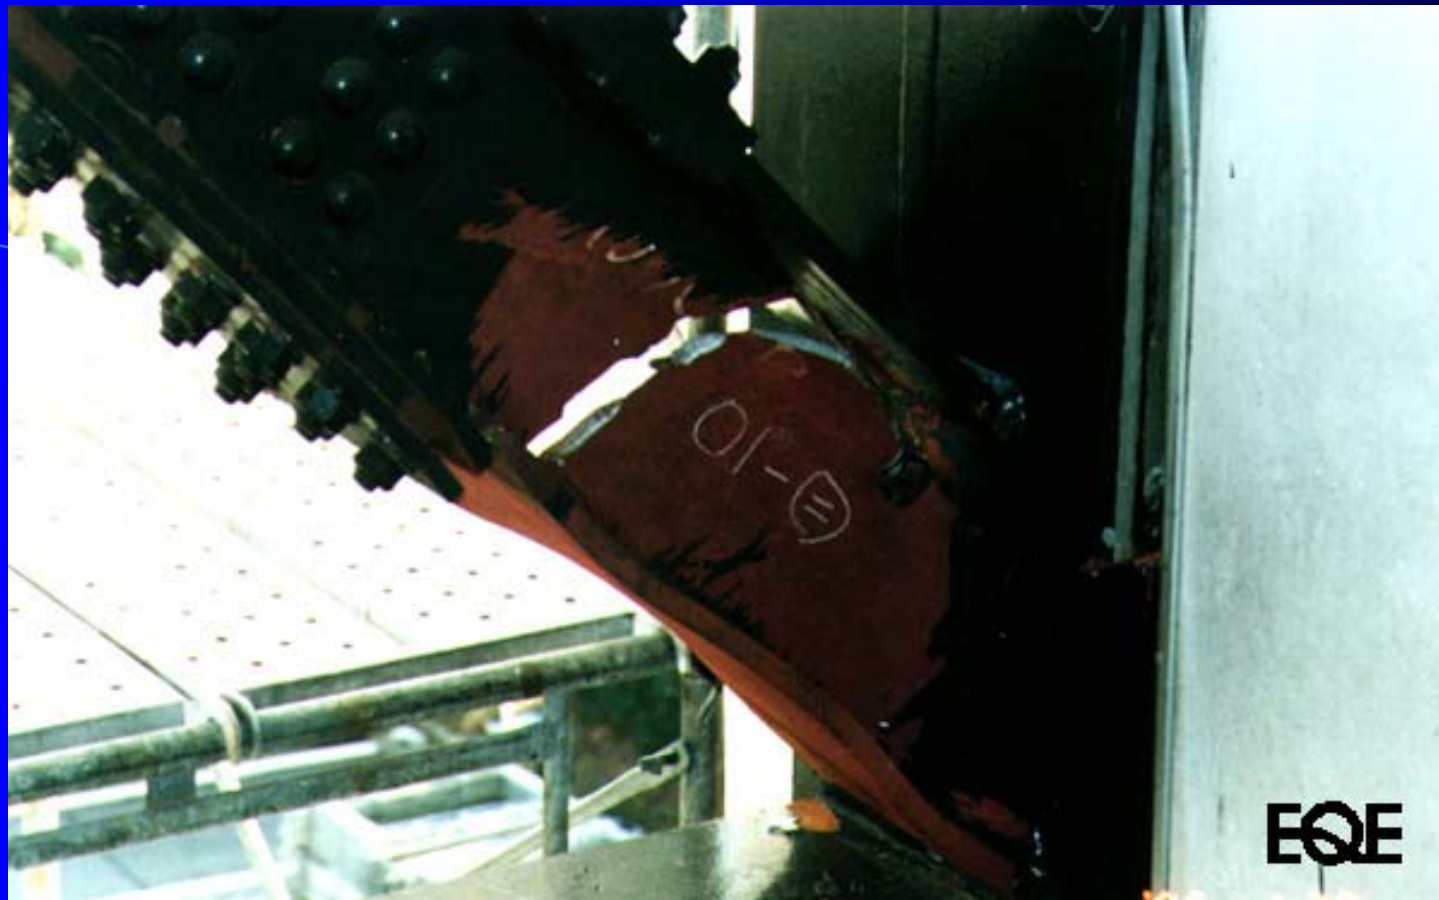
Brittle failure of bracing, due to high strain rate of the seismic action (Kobe Earthquake, 1995)

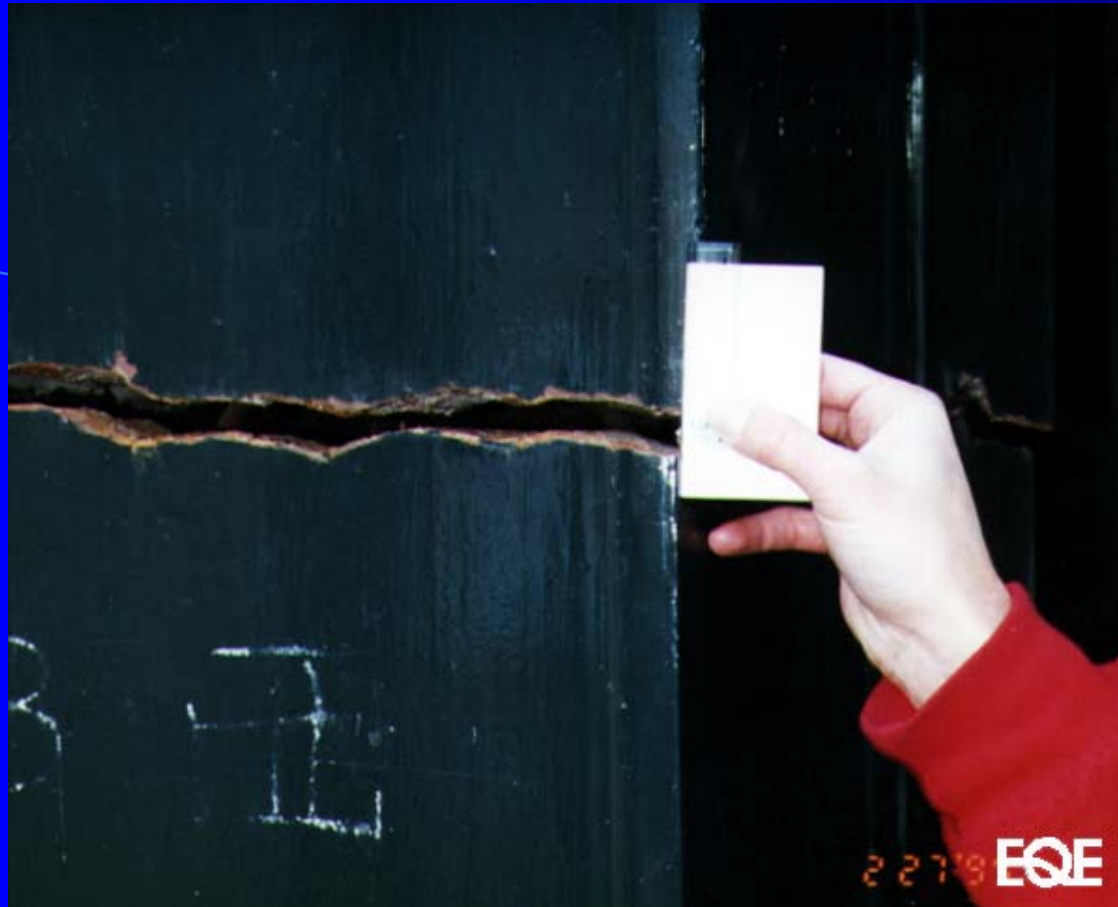
Brittle failure of box column, formed from welded plates, due to high vertical component of the seismic action, (Kobe Earthquake, 1995)

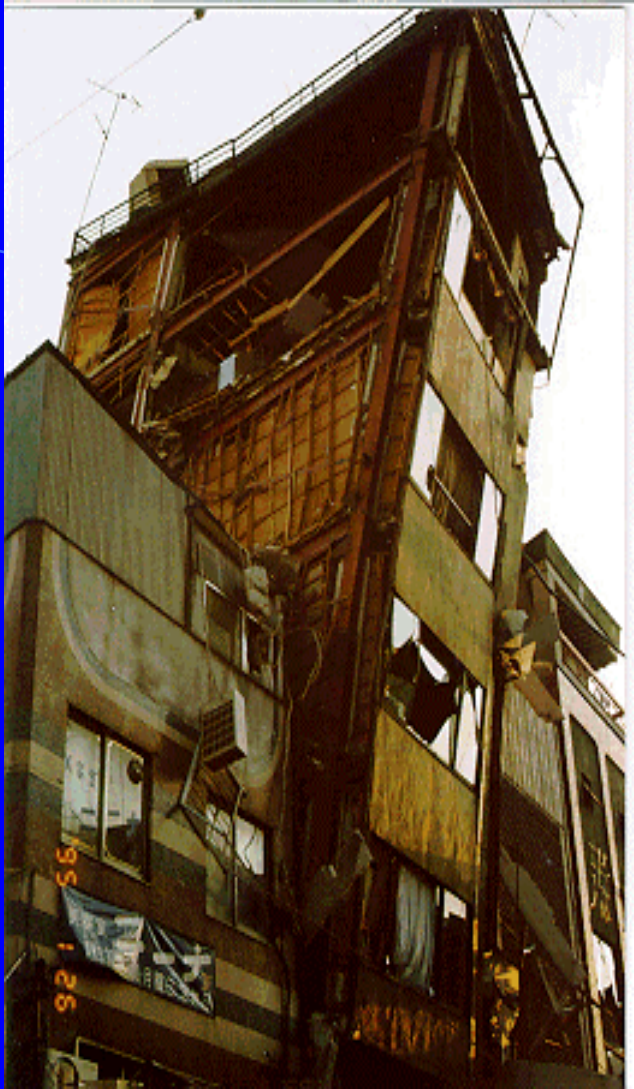
Excessive sway due to fracture of slender braces
(Kobe Earthquake, 1995)

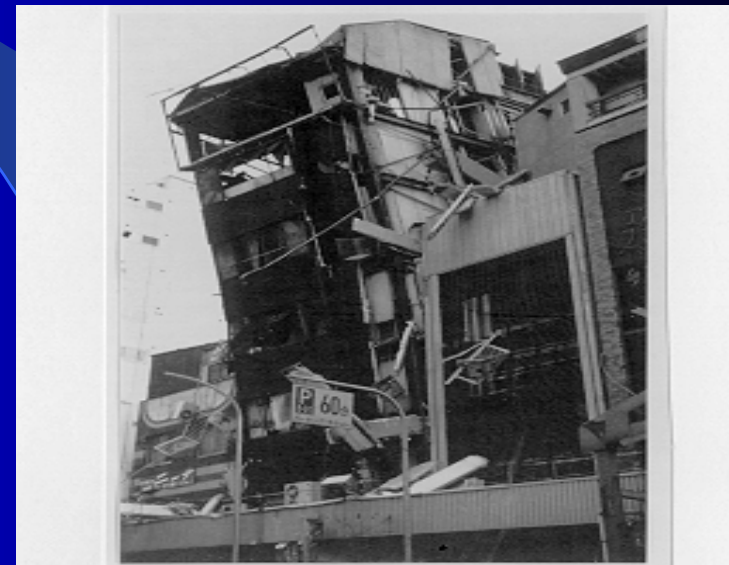
Fig. 6.91 Excessive sway due to fracture of slender braces

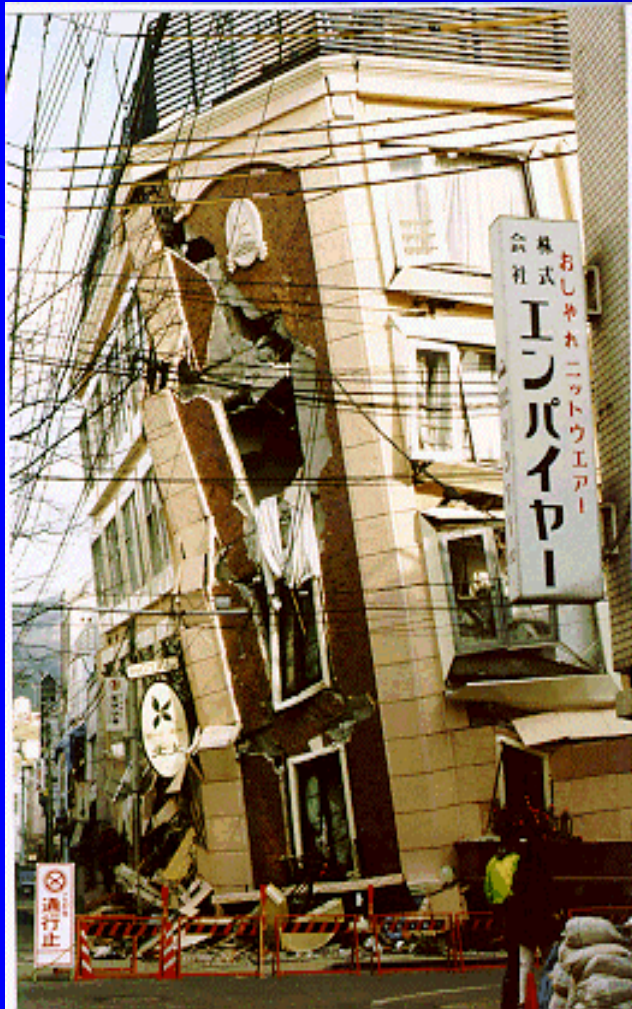
Tily up of a steel building
(Kobe Earthquake, 1995)

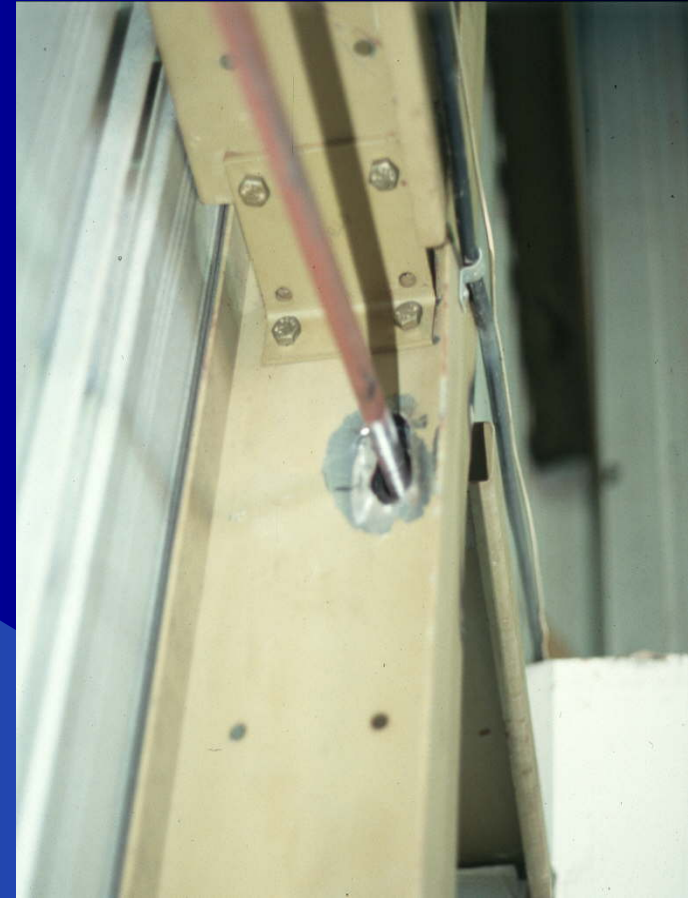
Hole Ovalization of slender bracings formed from rods (Northridge, 1994)

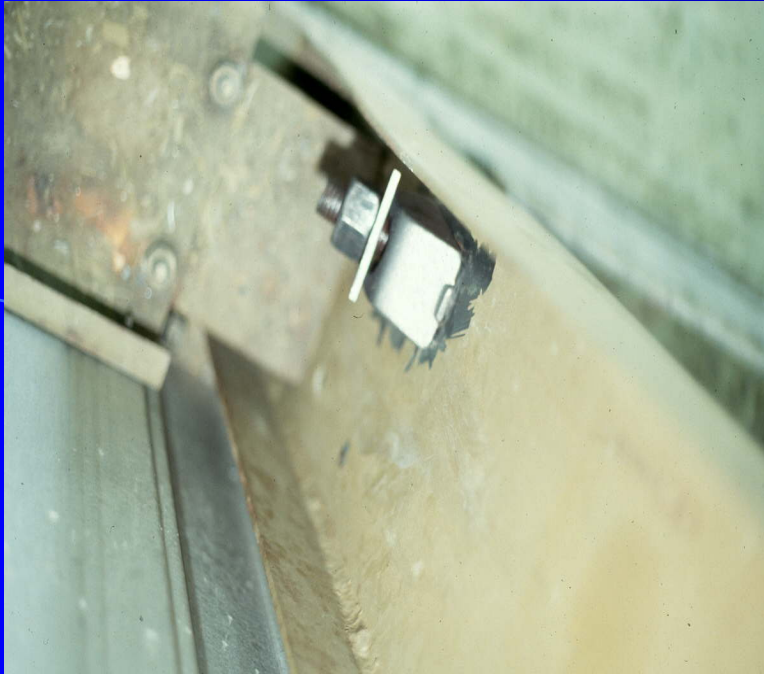
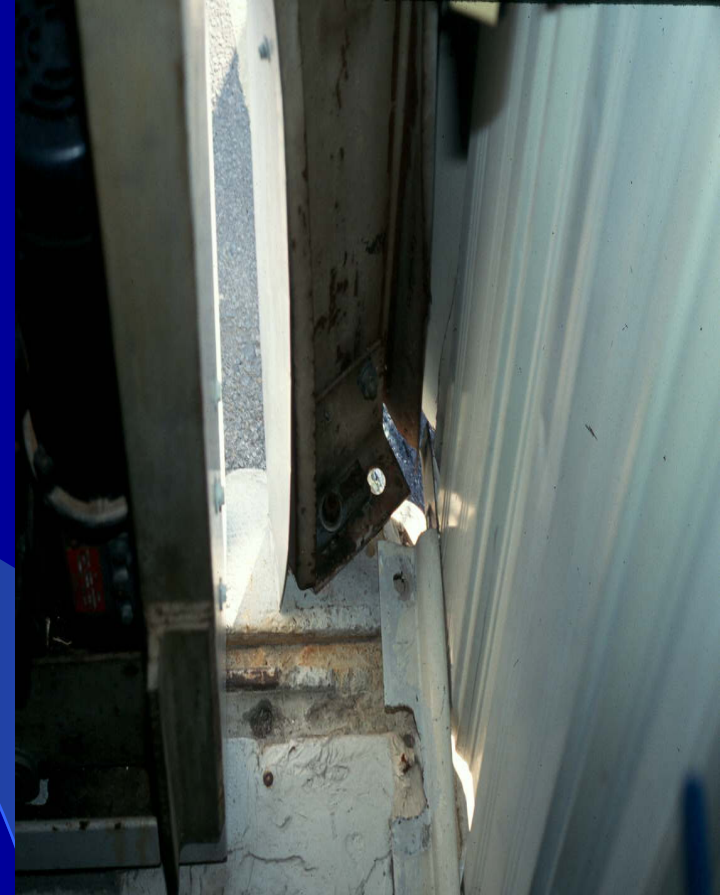
Failure of cladding in industrial building
(Northridge, 1994)

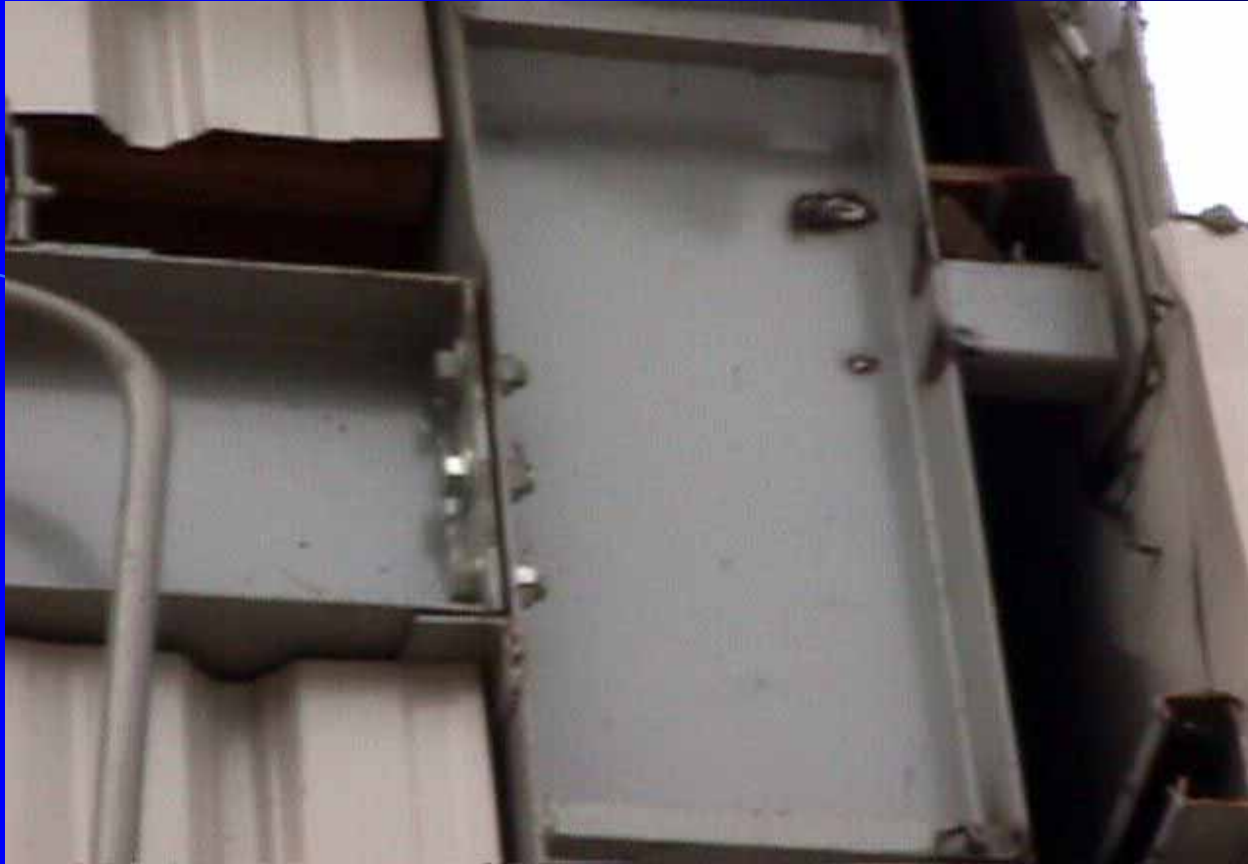
Panel zone yielding and local buckling of column flange
Earthquake of Taiwan

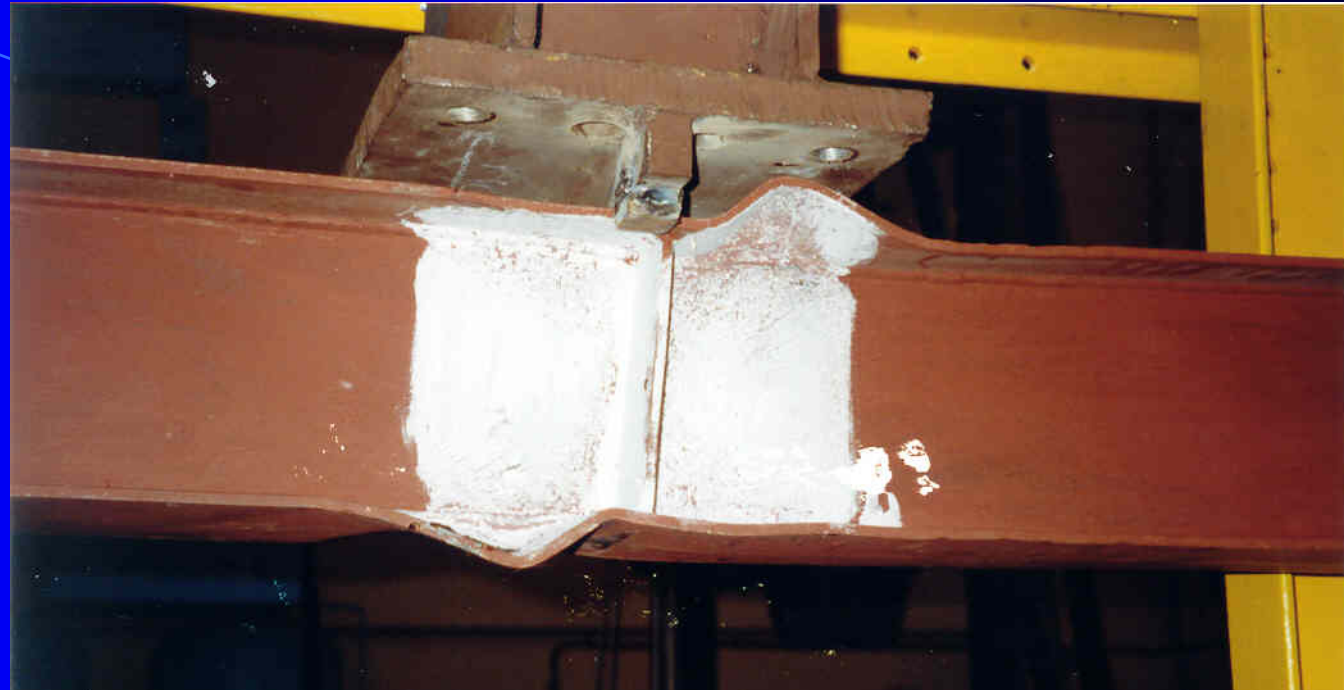
Local buckling of beam flanges. A type of plastic hinge working as a filter, absorbing seismic energy, in case of severe actions

(Mateescu-Anastasiadis 1998)

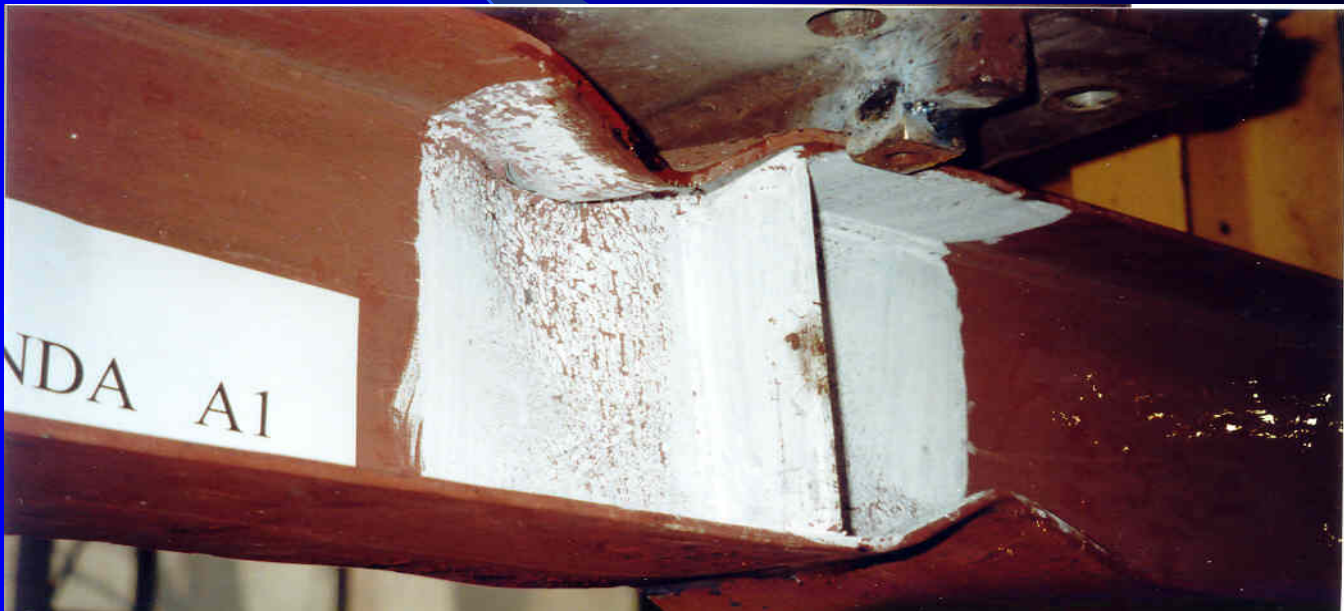
Local buckling of
beam flanges.
Symmetric buckling of
upper flanges

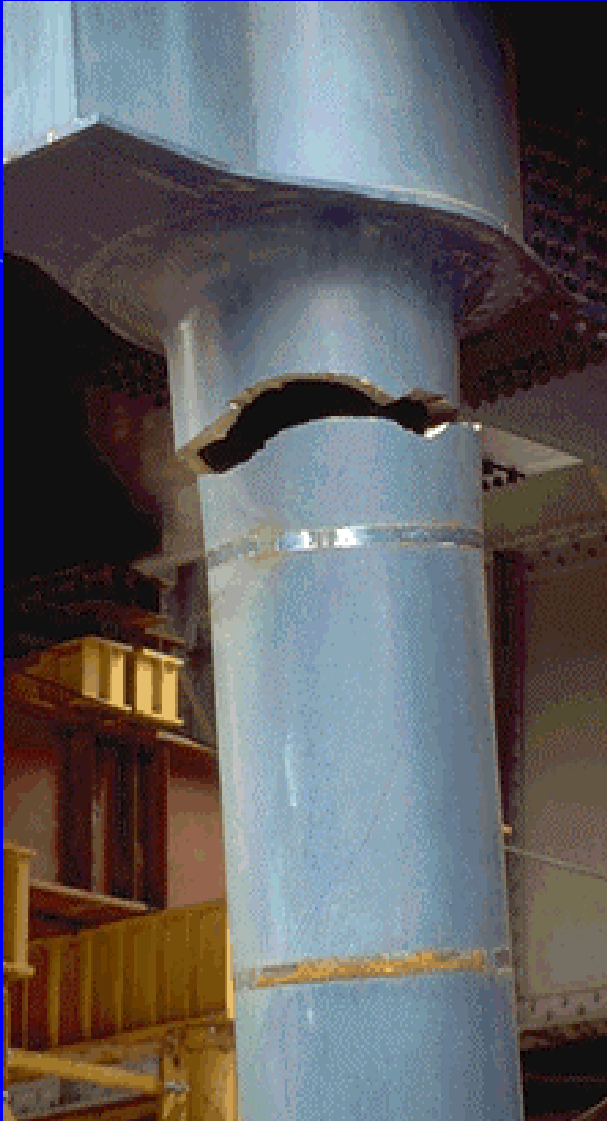
Brittle failure of a steel
circular pier simulating
damage from Kobe
Earthquake in Laboratory

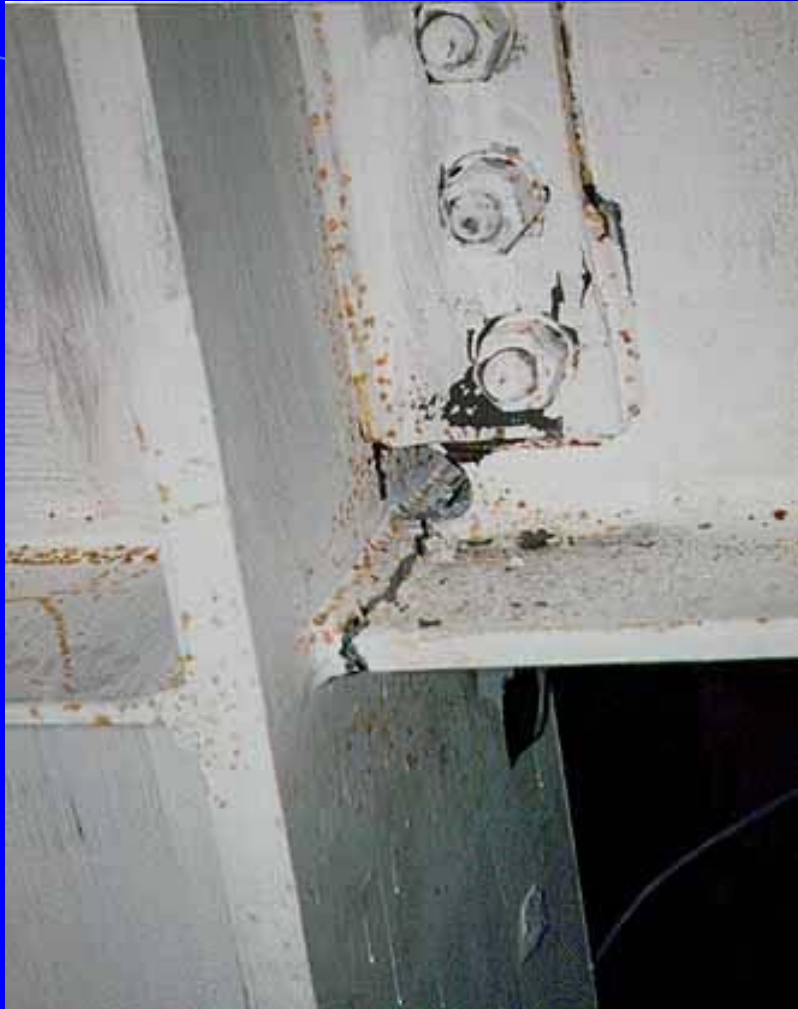
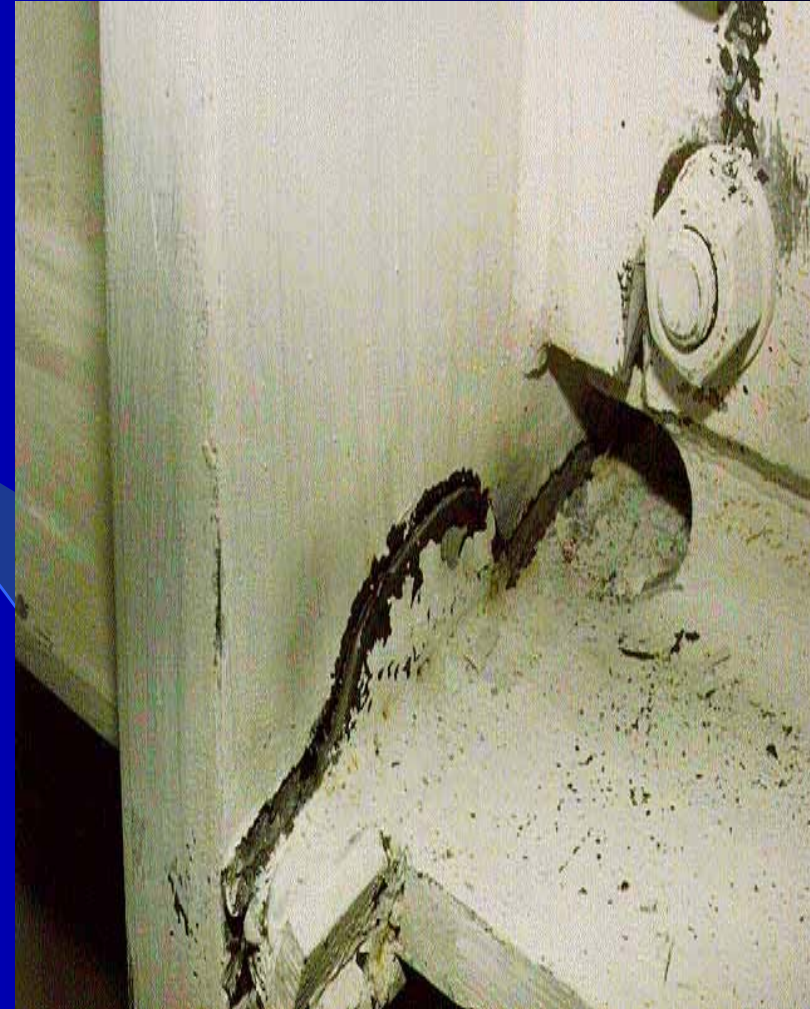
Brittle damage frequently observed at the bottom beam flange

The main target of SAC Program was to reproduce in laboratory condition the failures observed in Northridge earthquake

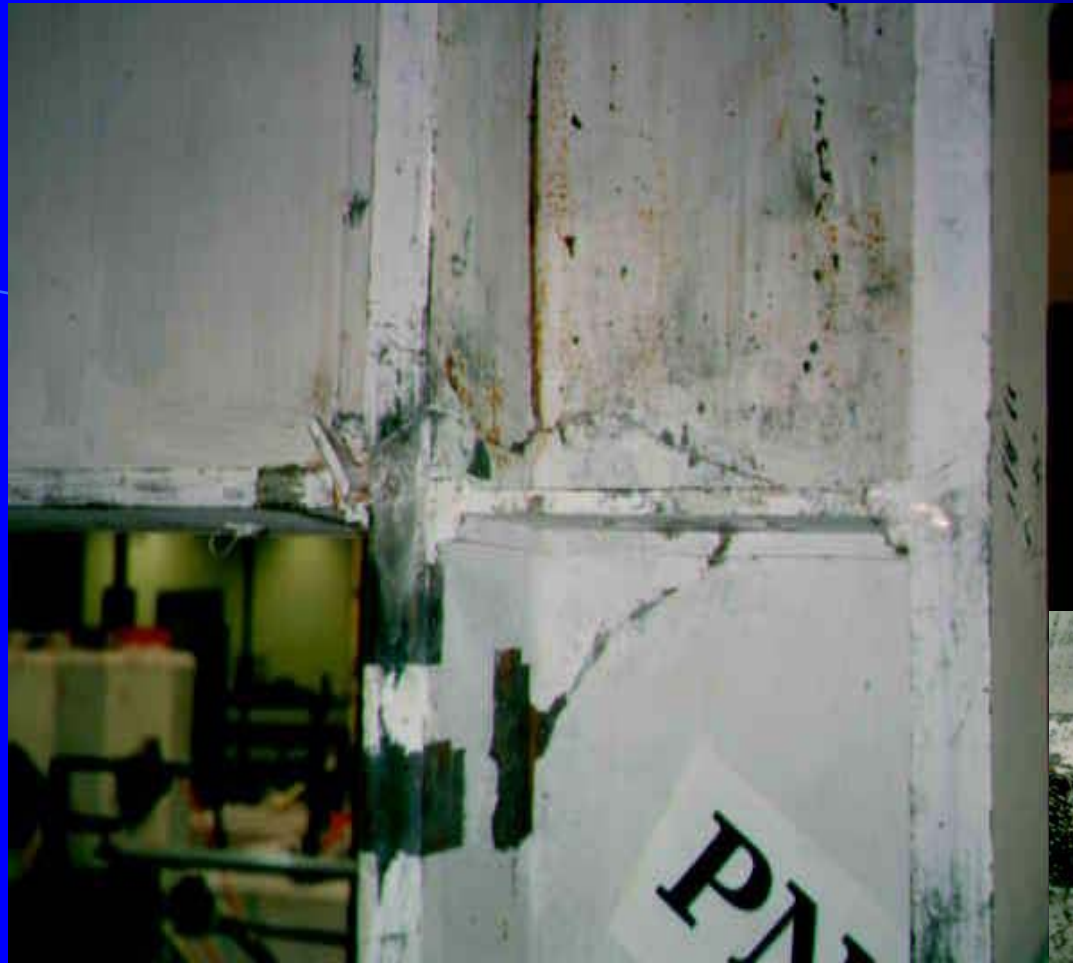
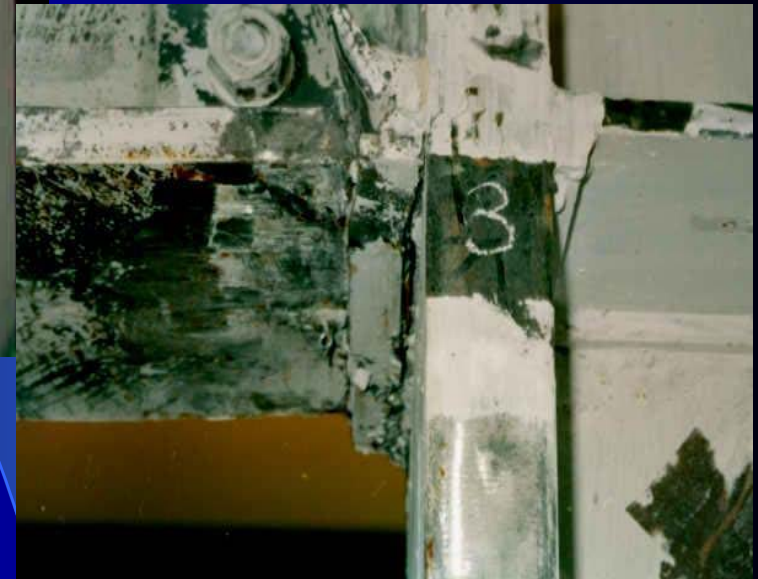
Brittle damage through base metal of the column flange
and panel zone

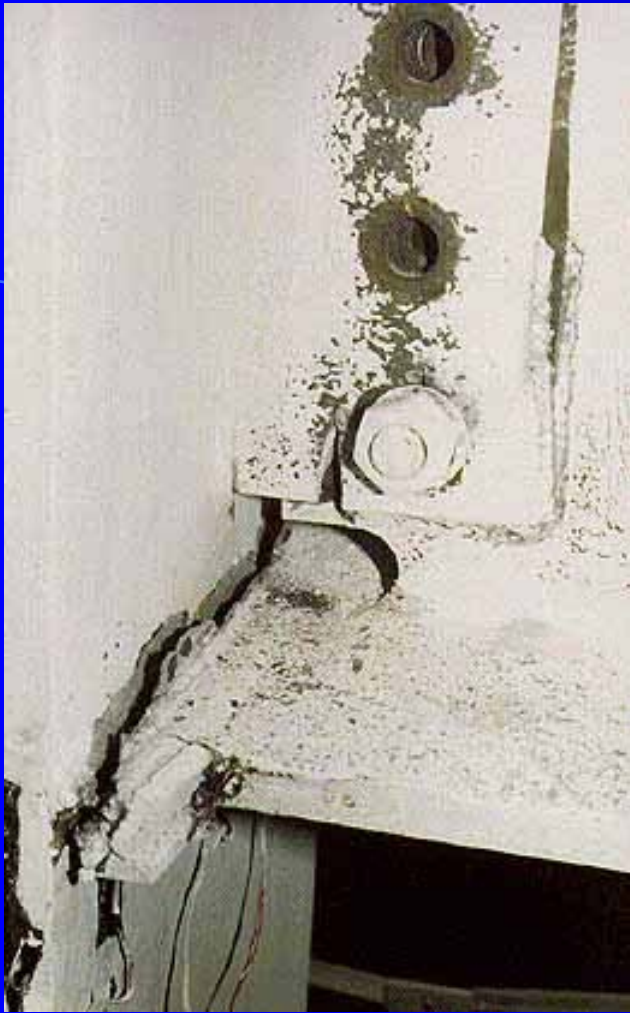
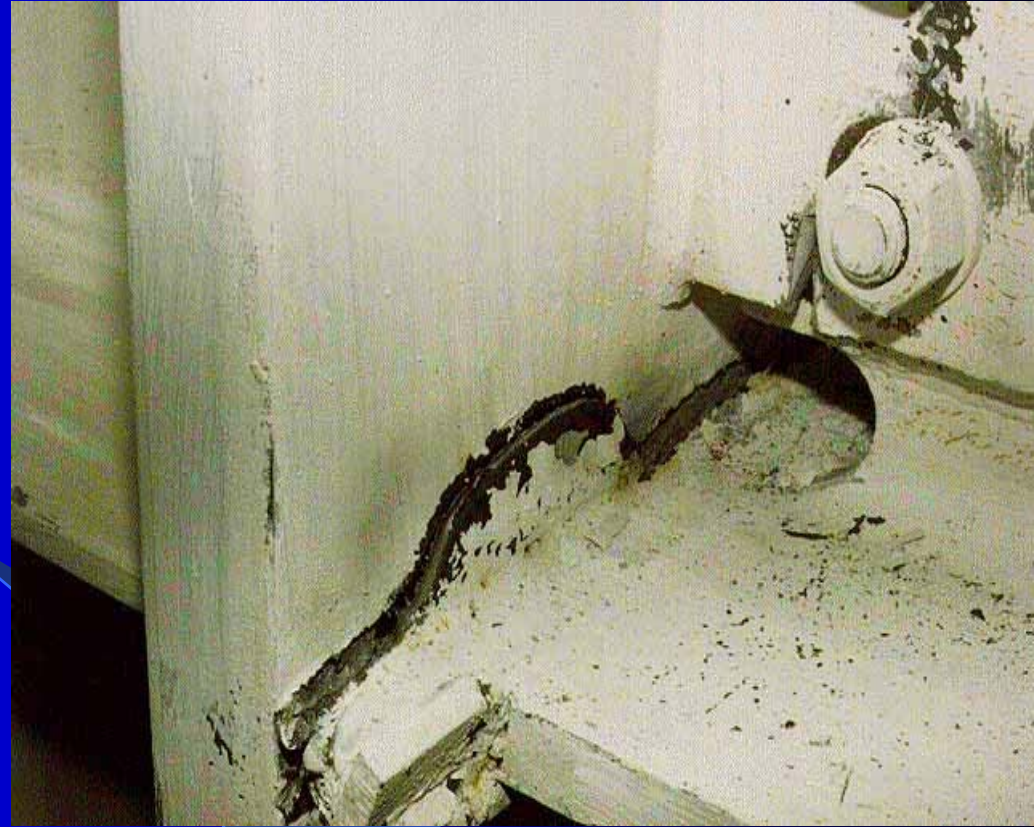
Brittle damage through base metal
of the column flange

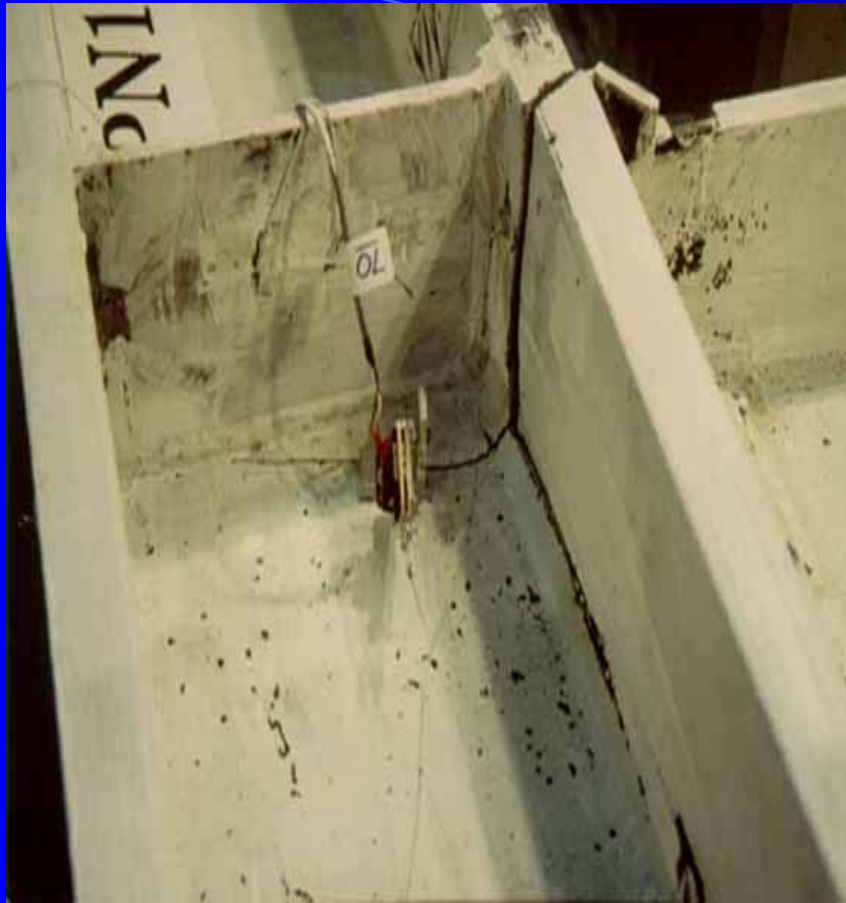
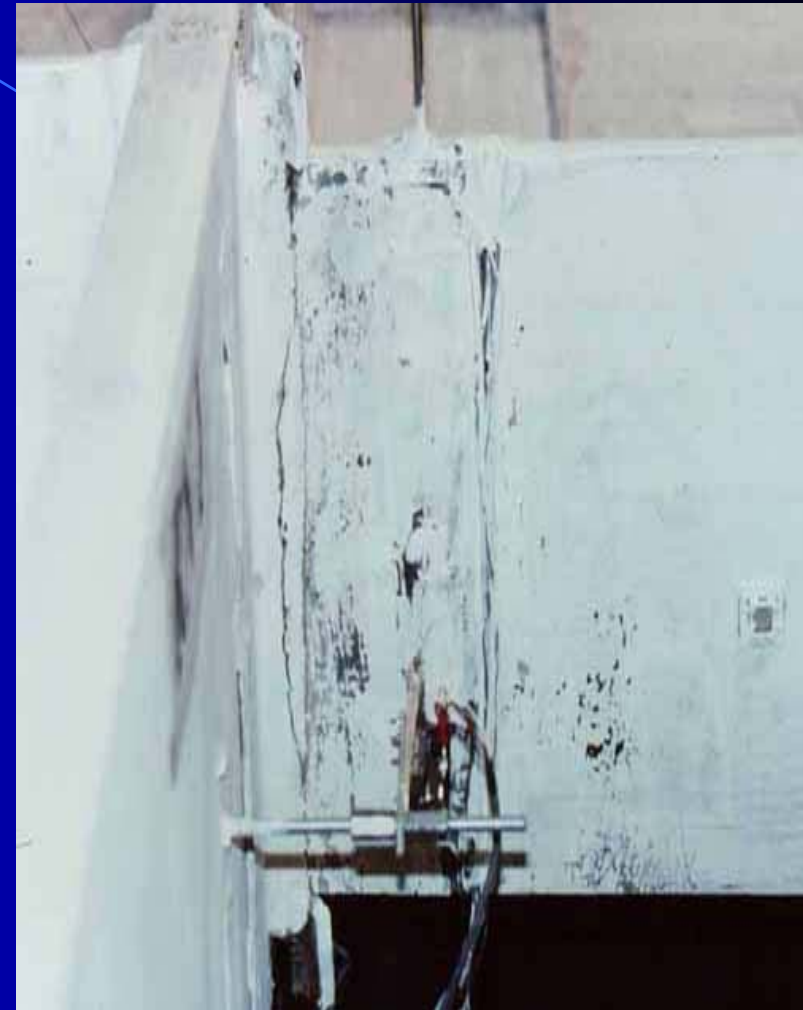
Local brittle damage at the interface of the beam – column connection

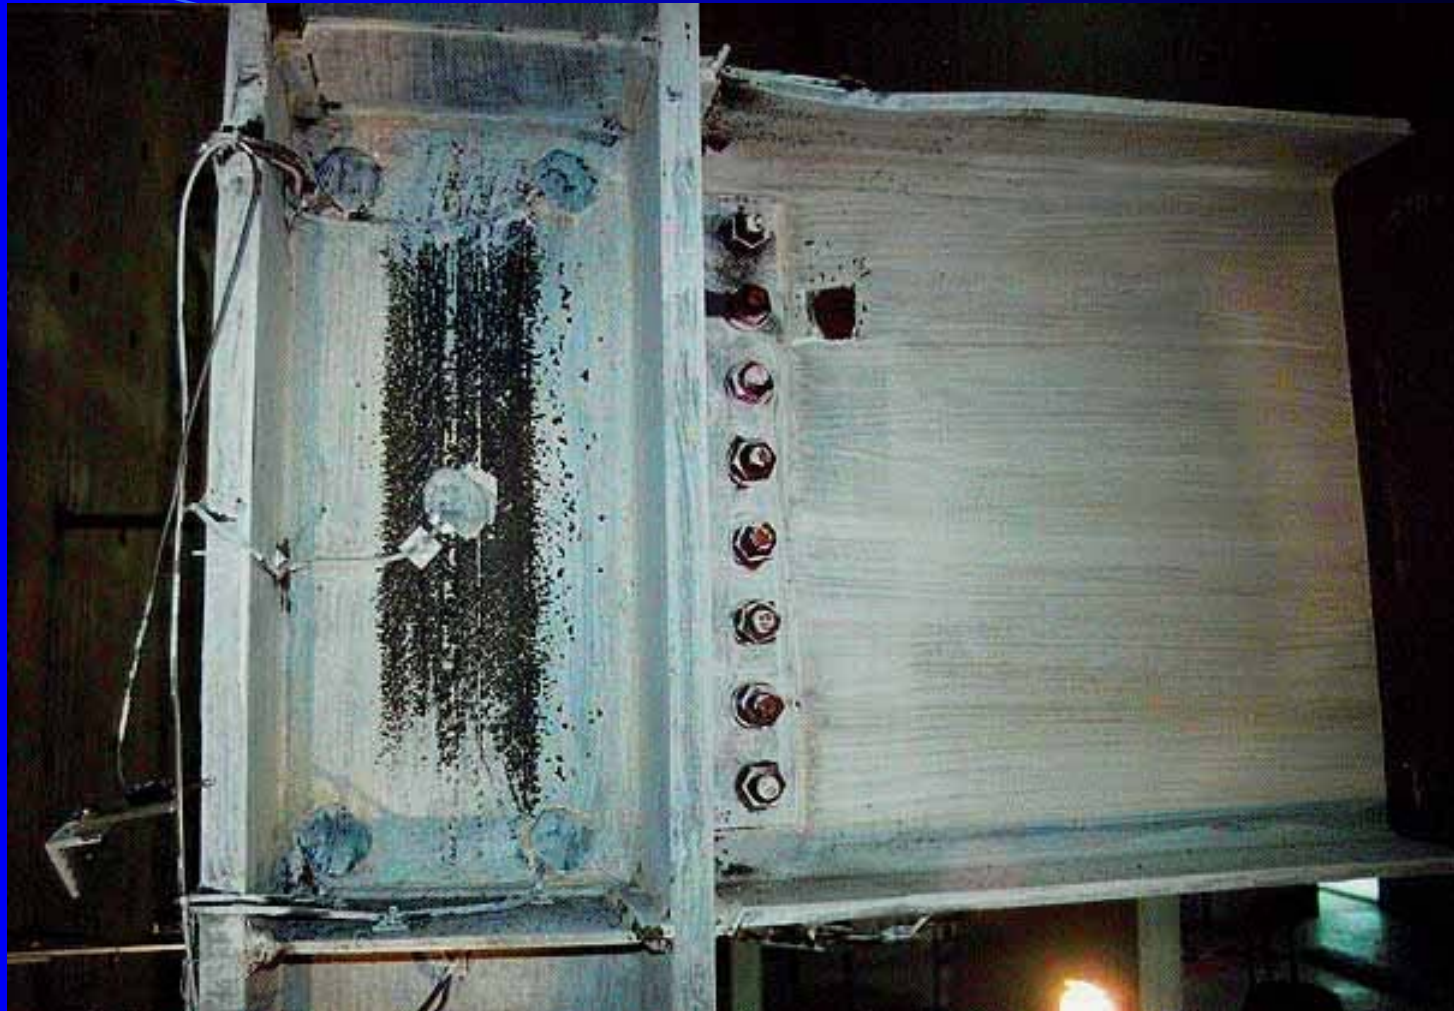
Panel zone yielding. Works as a filter against local brittle failures reducing the stress at the beam to column connection

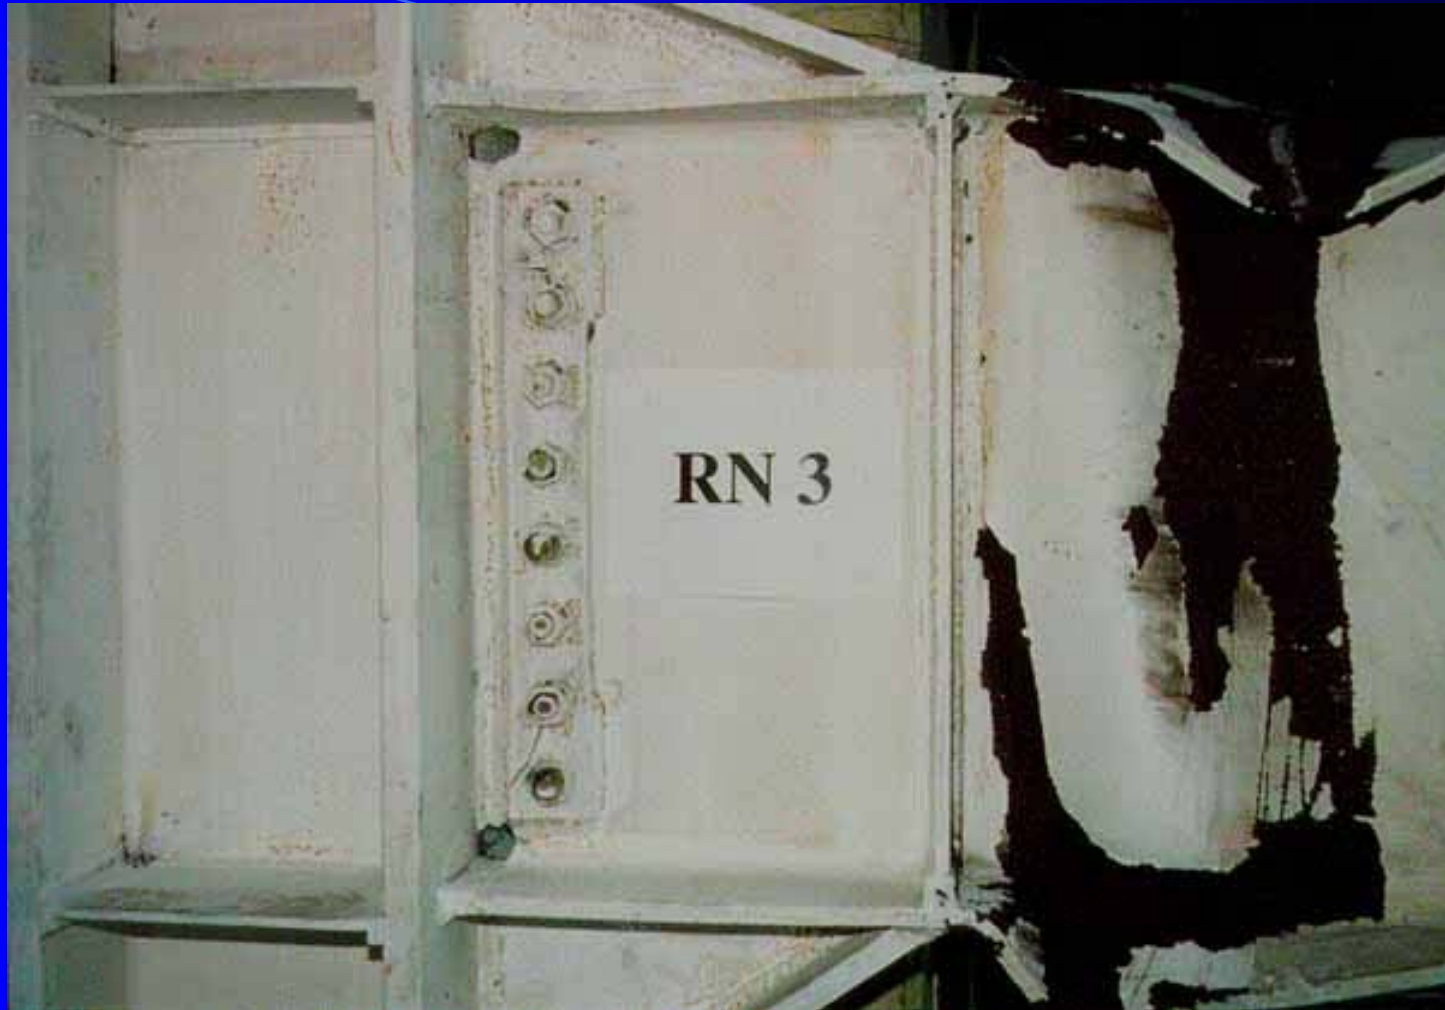
Formation of plastic hinge at some distance from the column face. Buckling of the beam flanges and severe yielding of beam's web

The aforementioned solution moves the formation of the plastic hinge at some distance from the highly stressed zone (interface of beam to column connection)
