Lecture in Department of Civil & Architecture School of UPT

**LESSONS LEARNED FROM RECENT EARTHQUAKES:
OBSERVED DAMAGE AND NEW TYPES OF STEEL
CONNECTIONS**

ANASTASIADIS ANTHIMOS

1st Part – OBSERVED DAMAGE FROM EARTHQUAKES

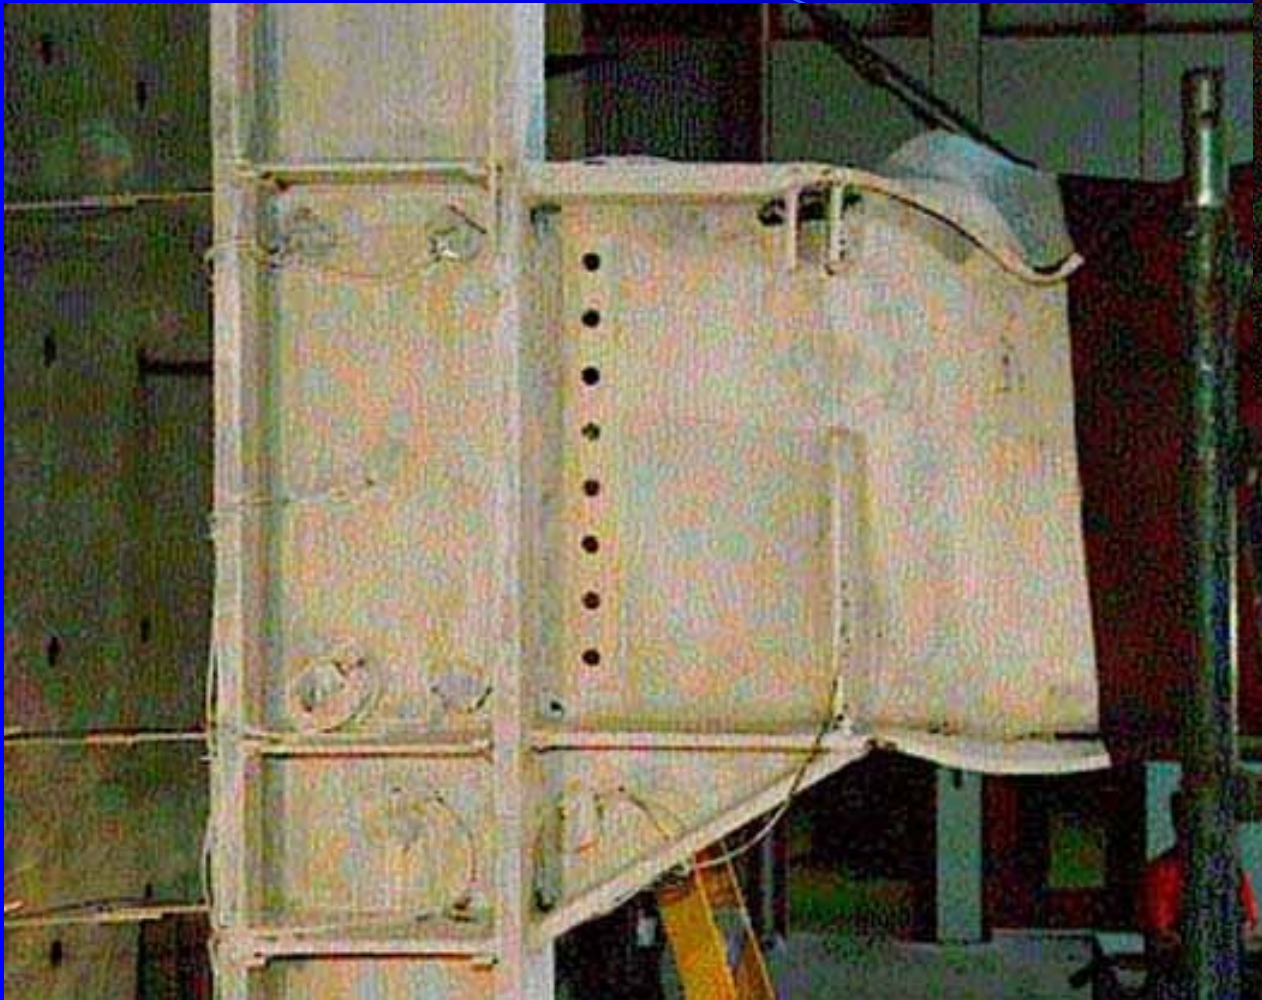
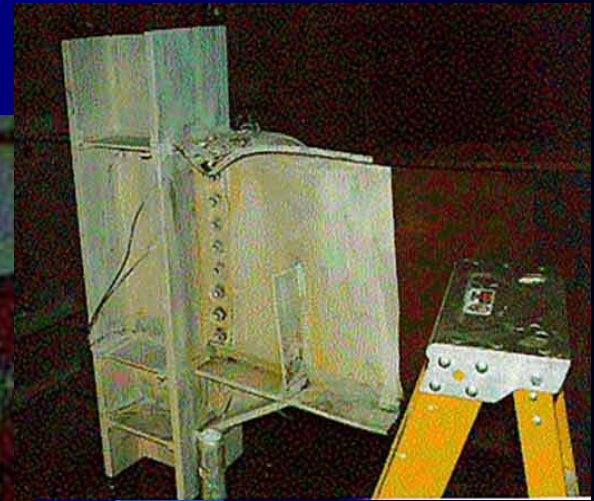
a) Strengthening using only a rib, at the bottom, and stiffeners

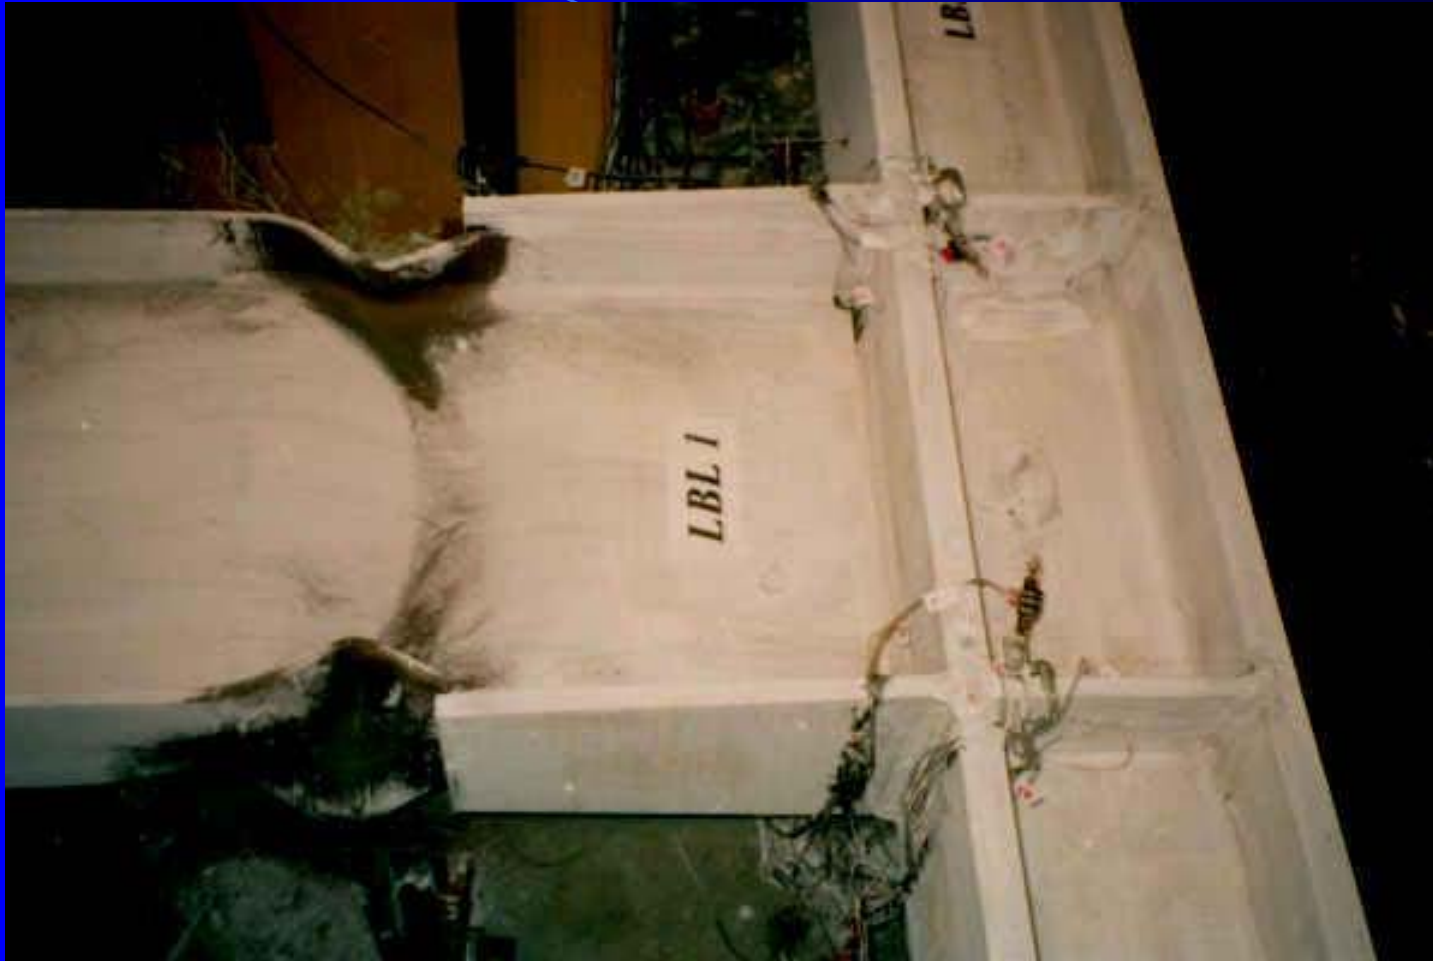
Strengthening using
cover plates

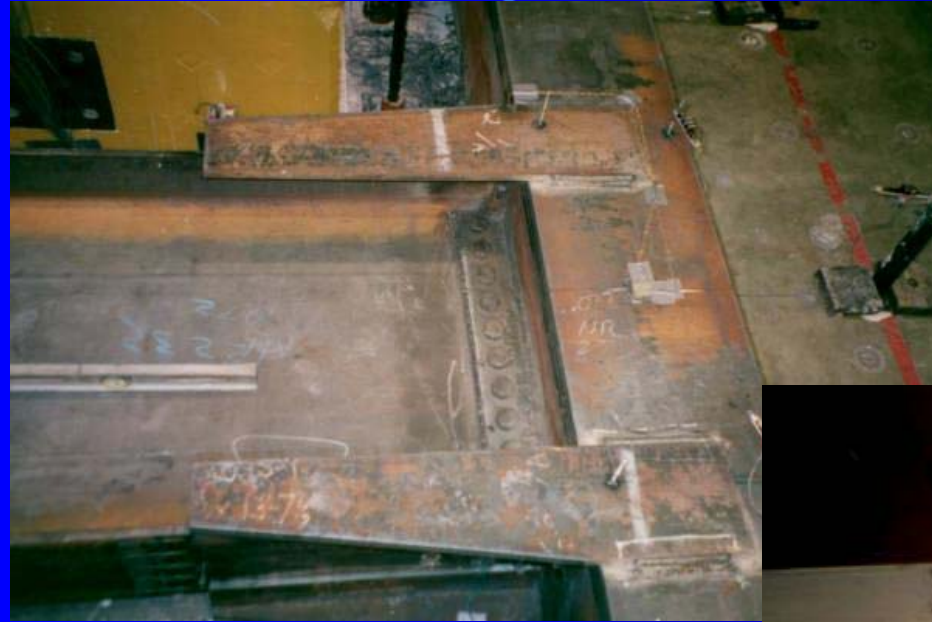
Strengthening using
side plates

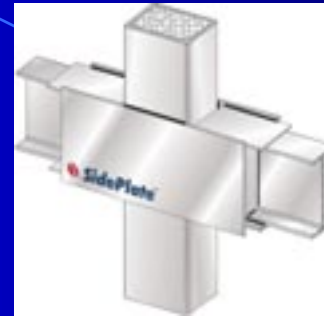
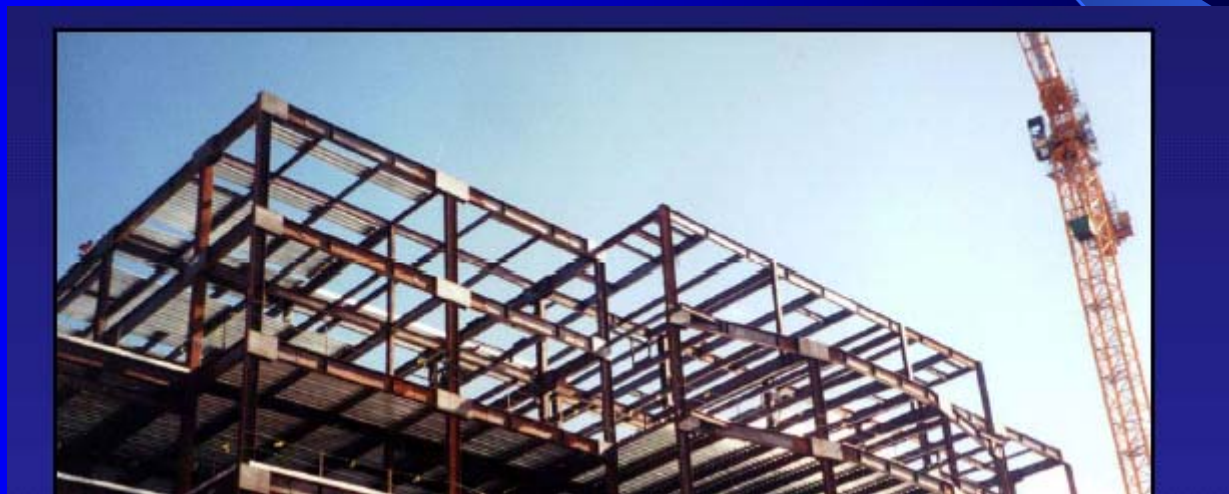
Strengthening using
side plates

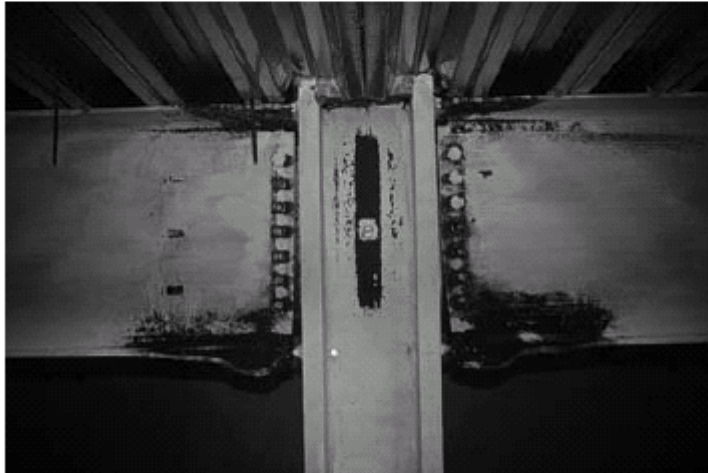
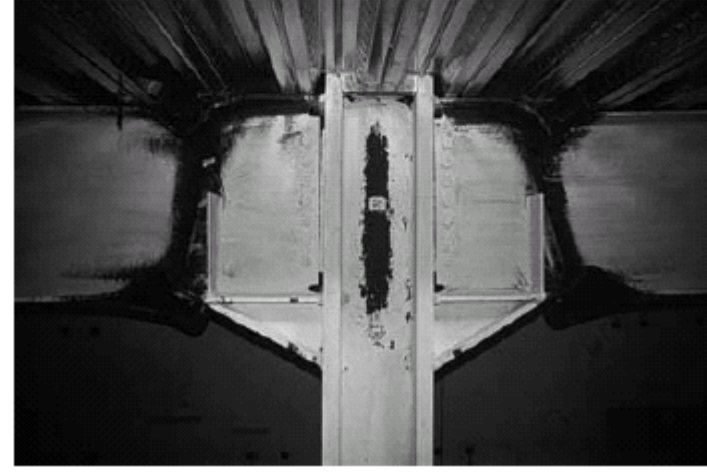
Influence of the r/c slab (Civijan & Enghelhard)

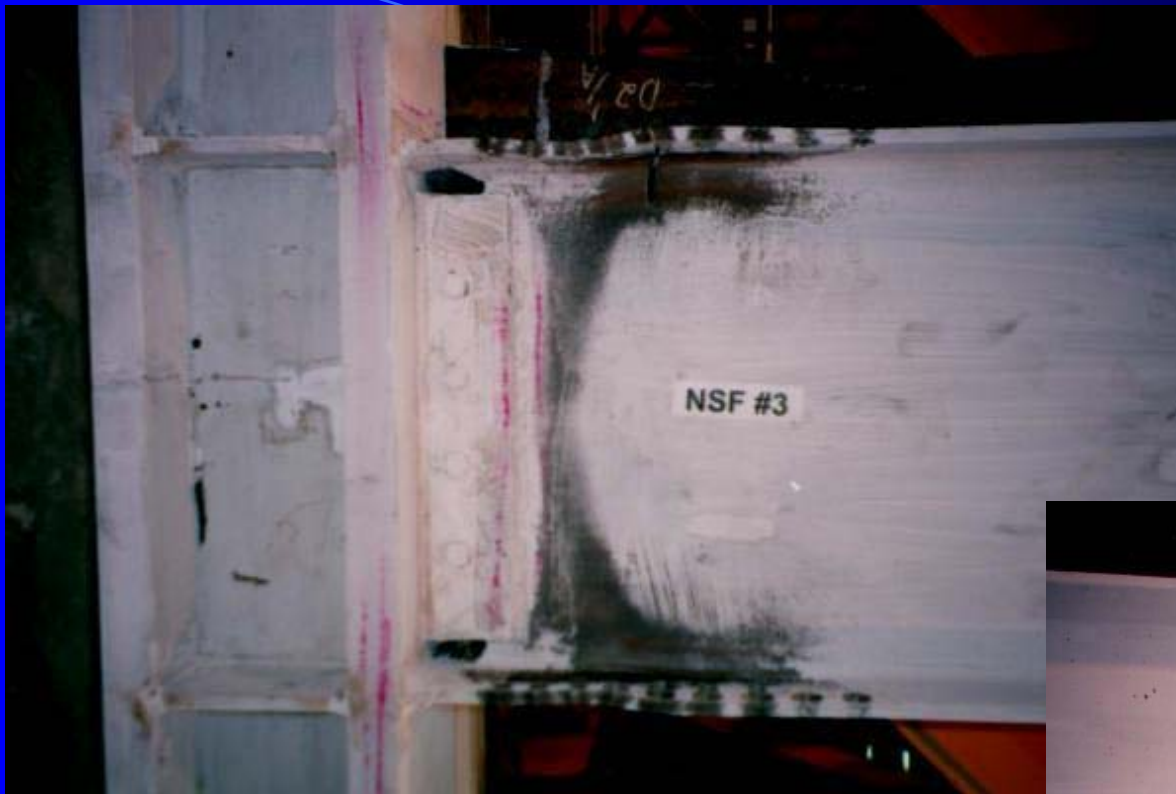
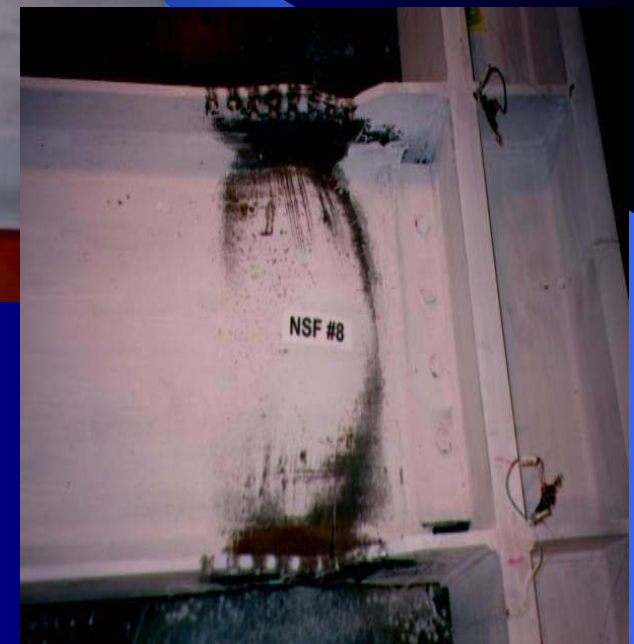
RBS with drilled flanges. Move the formation of the plastic hinge at the drilled zone protecting the connection

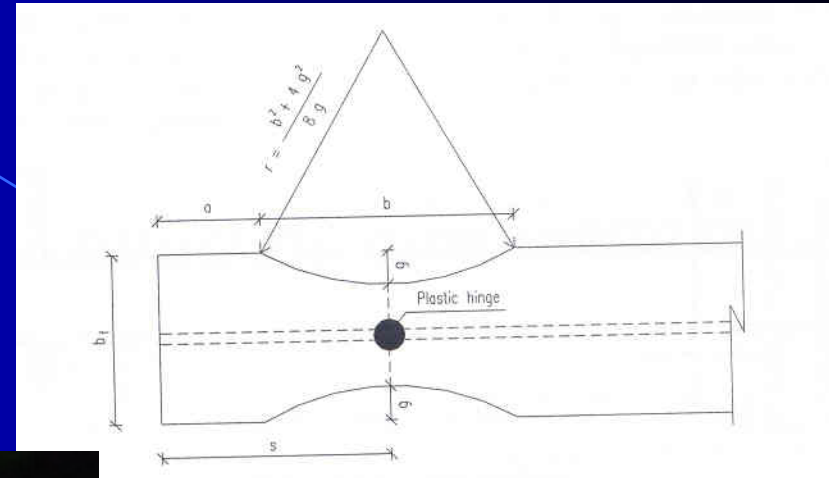
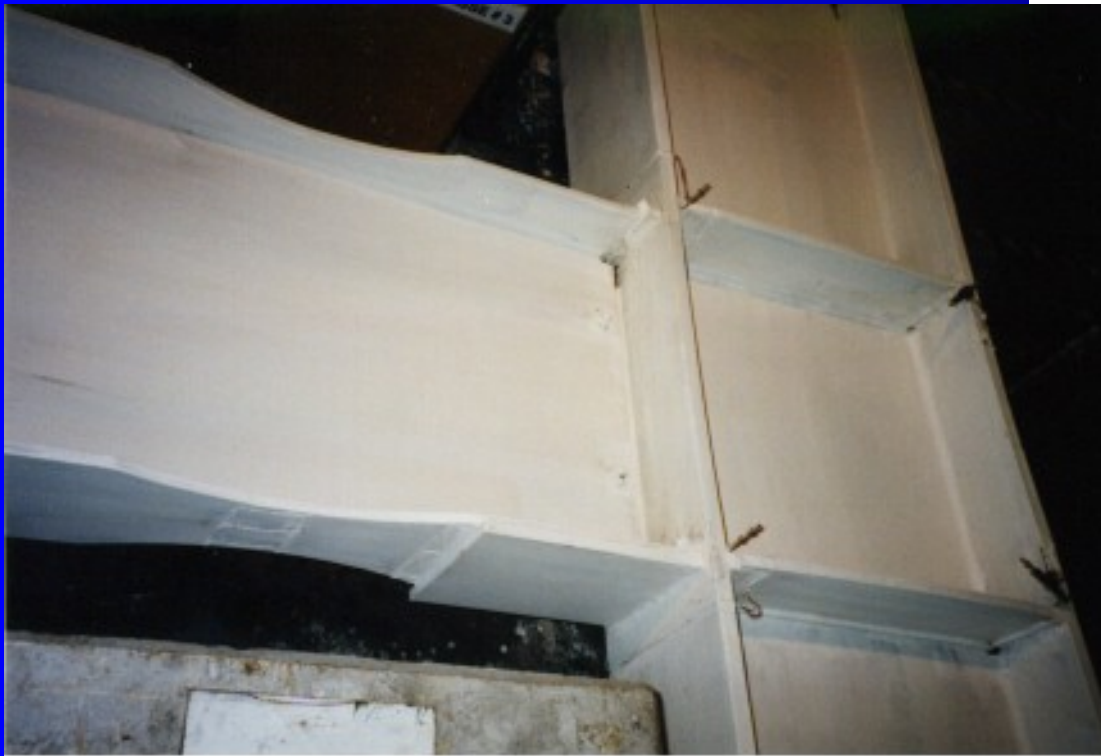
RBS with radius cut of beam flanges.

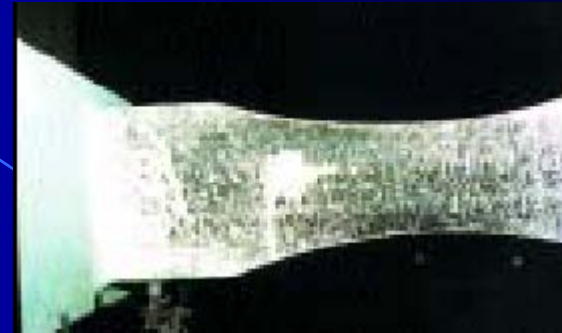
Formation of plastic
mechanism

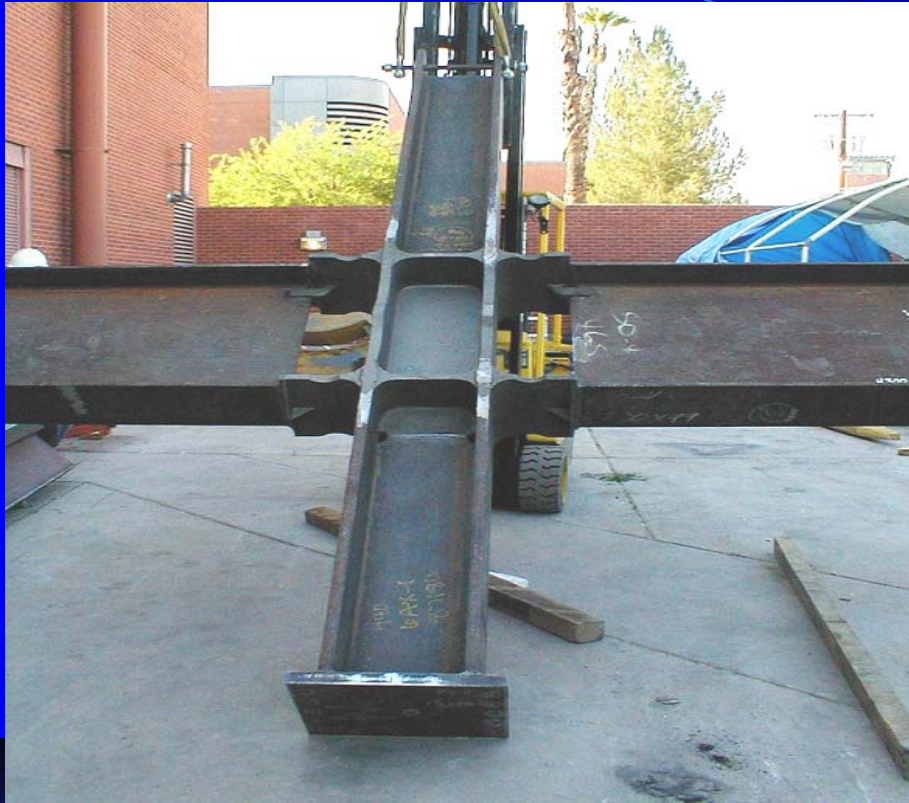
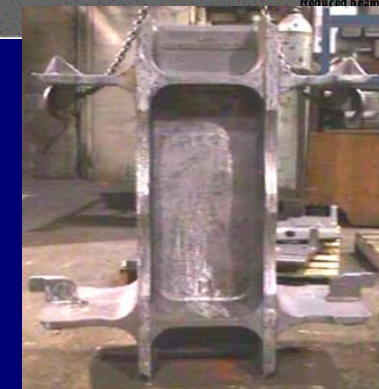
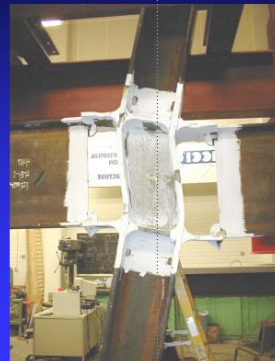
Modular connections
